Prince George's County Countywide Watershed Assessment for MS4 Permit (2014–2019)

Prepared For

Prince George's County, Maryland
Department of the Environment
Stormwater Management Division

Prepared By

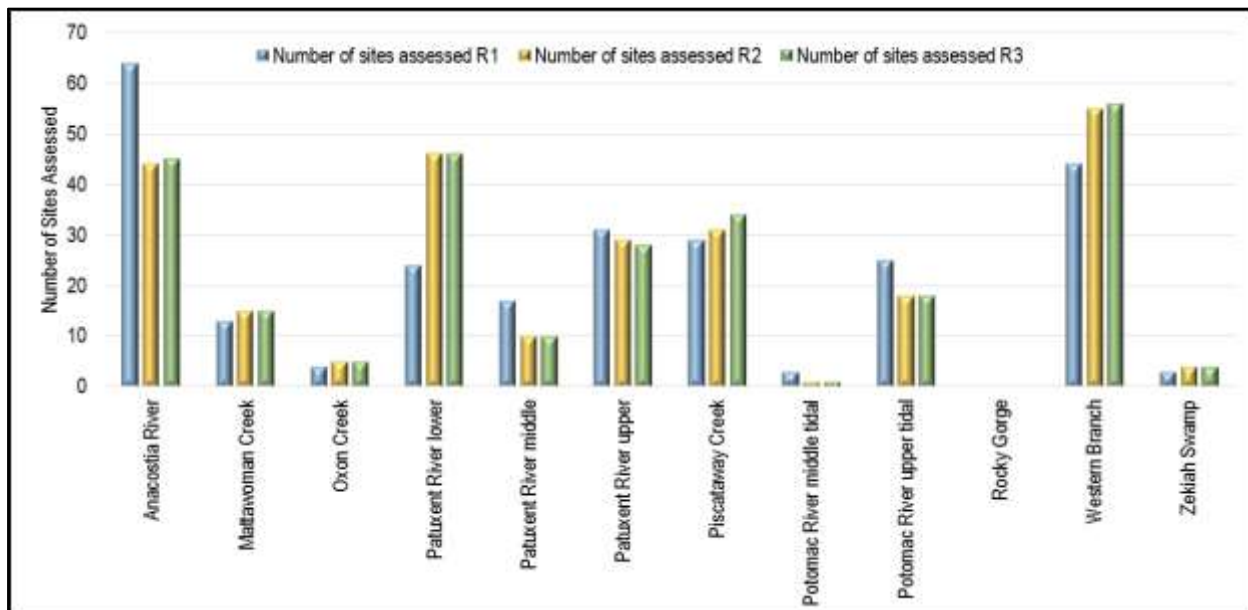
Figure 2-1. Number of stream sites sampled by biological assessment round.

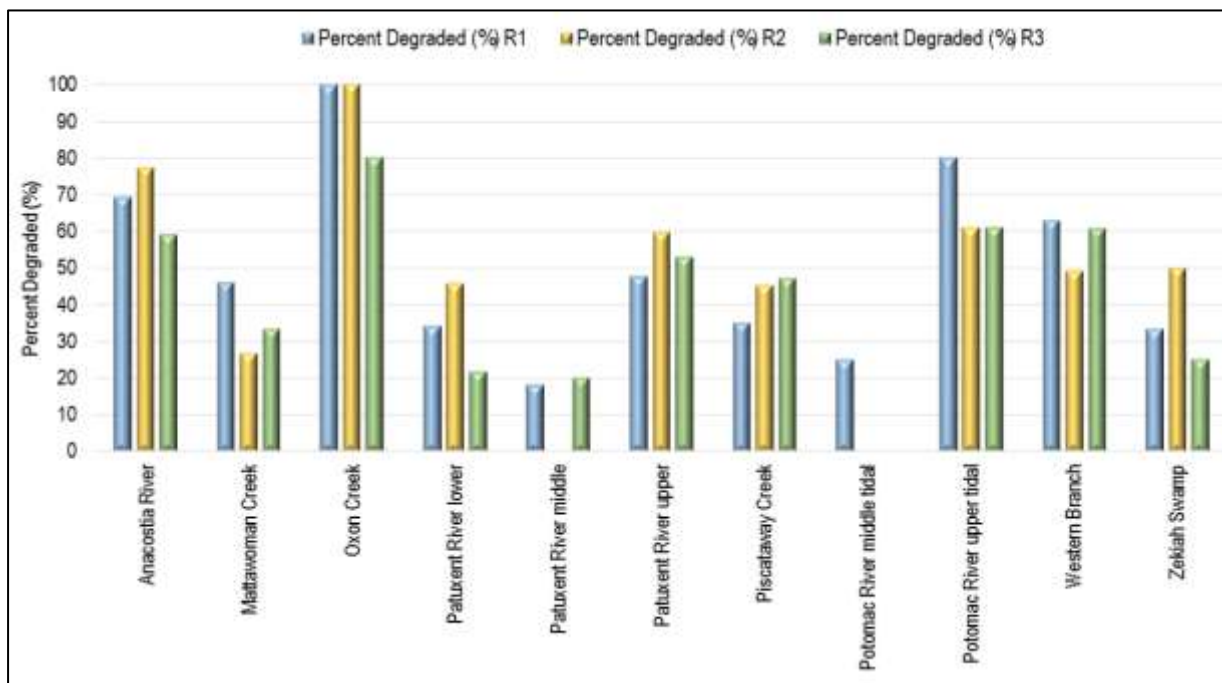
Notes: Where bars for individual rounds are missing, assessments were 0% degradation (e.g., Patuxent River middle for R2). There were no assessment locations in the Rocky Gorge watershed.

Figure 2-2. Percent degradation per watershed by biological assessment round.

Three of the 8-digit watersheds—Anacostia River, Western Branch, and Potomac River upper tidal—consistently had high percentages of degraded sites through all three assessment rounds (Figure 2-2). The relatively small Oxon Creek watershed consistently showed the highest percentages of degraded sites. There were no biological assessment locations in the Rocky Gorge watershed. The watersheds with lower percentages of degraded sites were generally in the eastern and southeastern parts of the County.

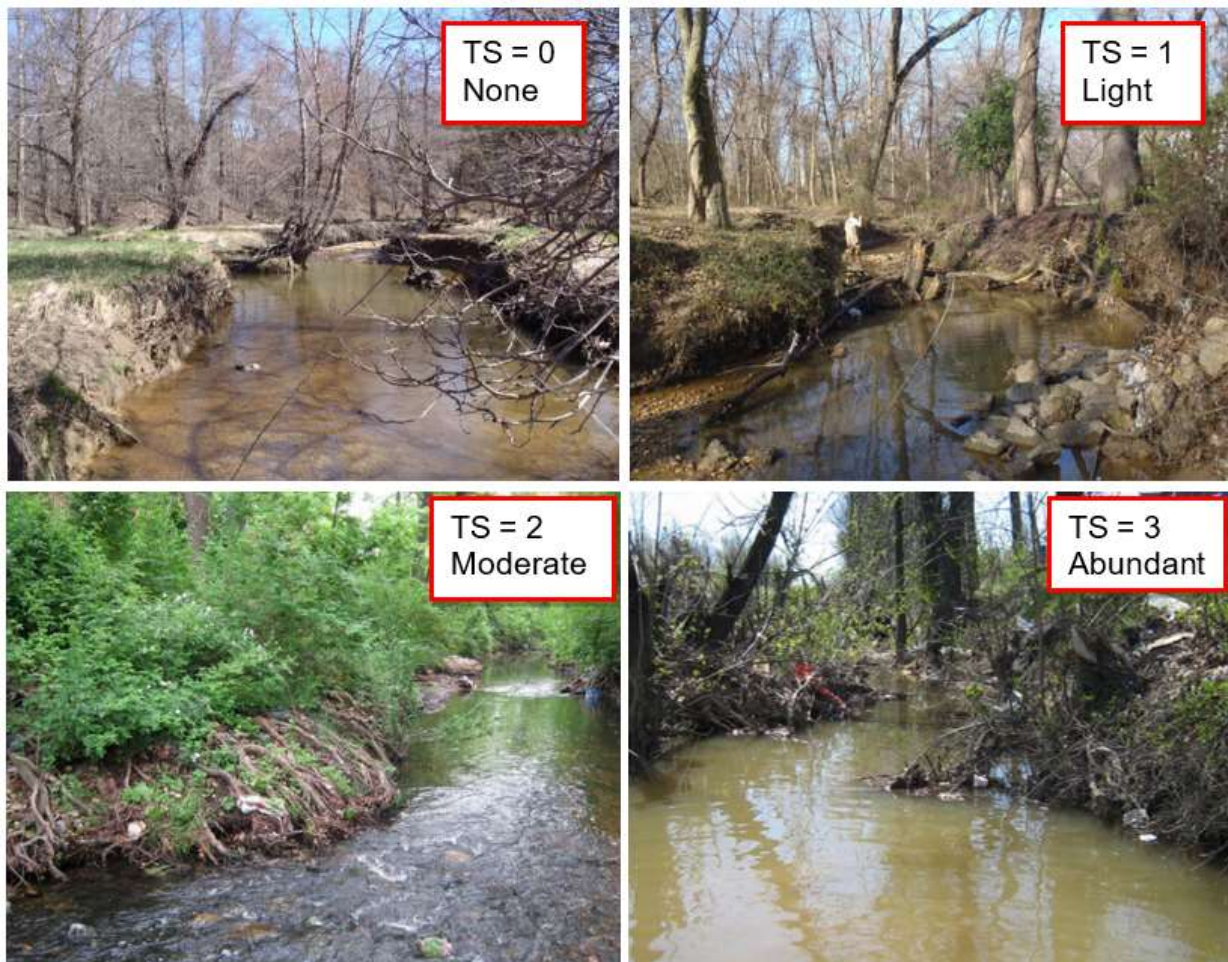
Figure 3-2. Streams illustrating different amounts of trash and corresponding trash scores.

Figure 3-2 shows four photographs that illustrate each major level on the rating scale. After each photo from a site was rated, a combined score for all the photos taken at the site was calculated. The TS for a single site ranged from 0 (no trash) to 12 (abundant or heavy trash).

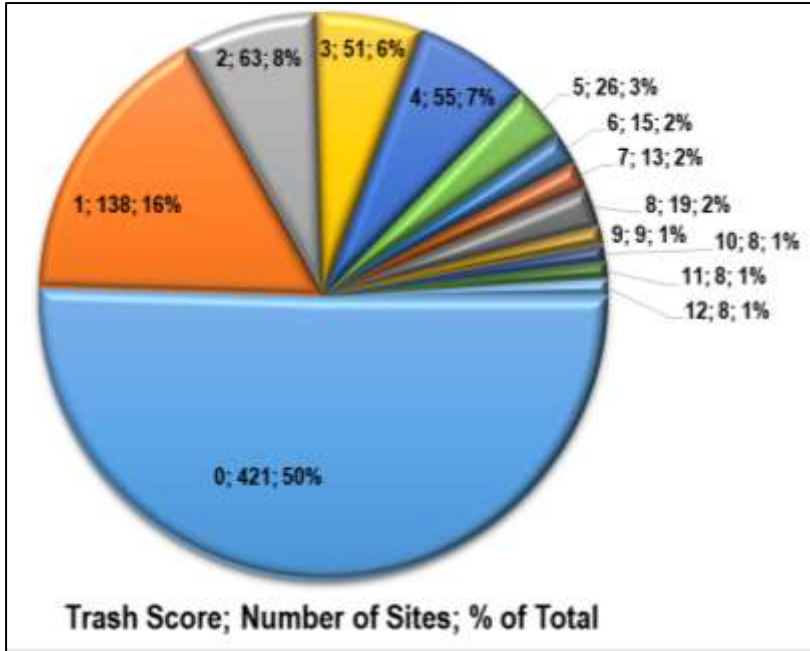
Figure 3-3. Trash score distribution throughout the County.

Throughout the County, about half the assessed sites were trash free (Figure 3-3); the majority of sites with the highest TSs (i.e., that had the most trash) were found in western portions of the County (Figure 3-4), largely inside the Beltway and immediately to the north and south of the Beltway. Trash levels in the Anacostia River, Patuxent River upper, and Potomac River upper watersheds appear to have decreased over time, while levels in the Piscataway Creek watershed might have increased.

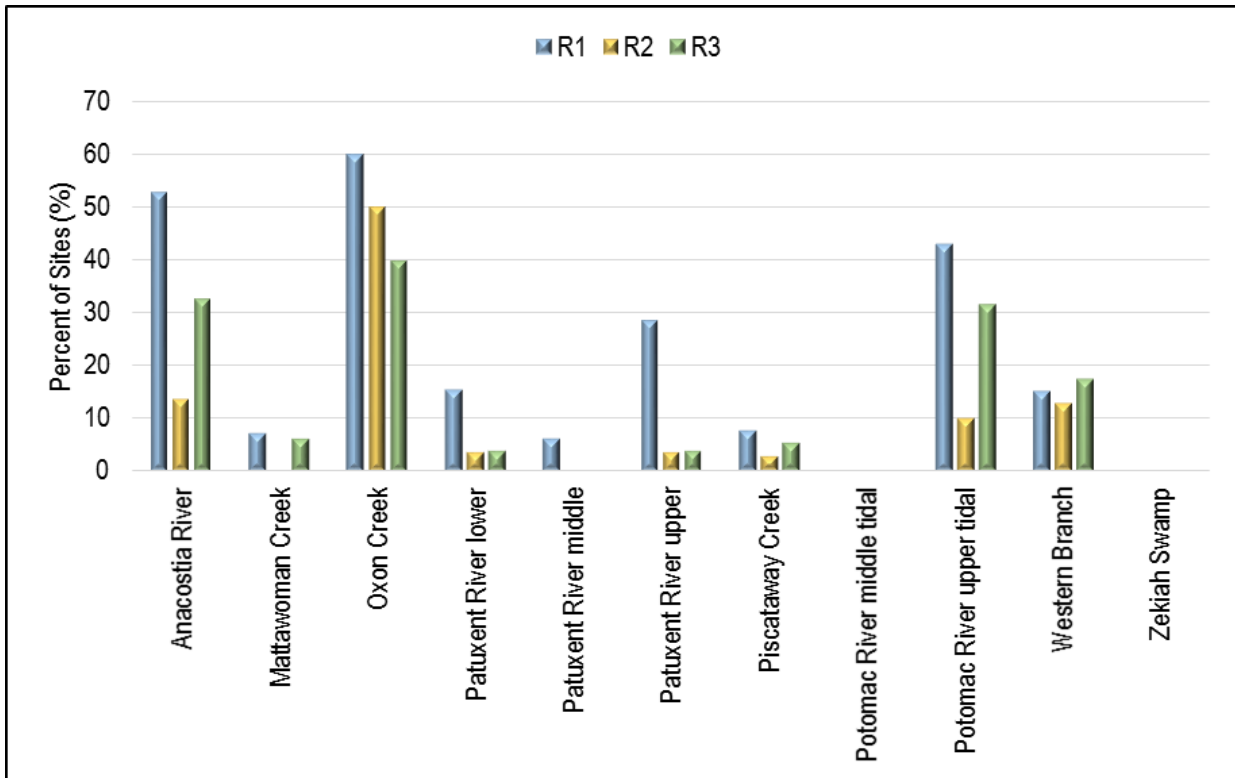
Figure 3-5. Percent of sites with trash scores higher than 4 by assessment round.

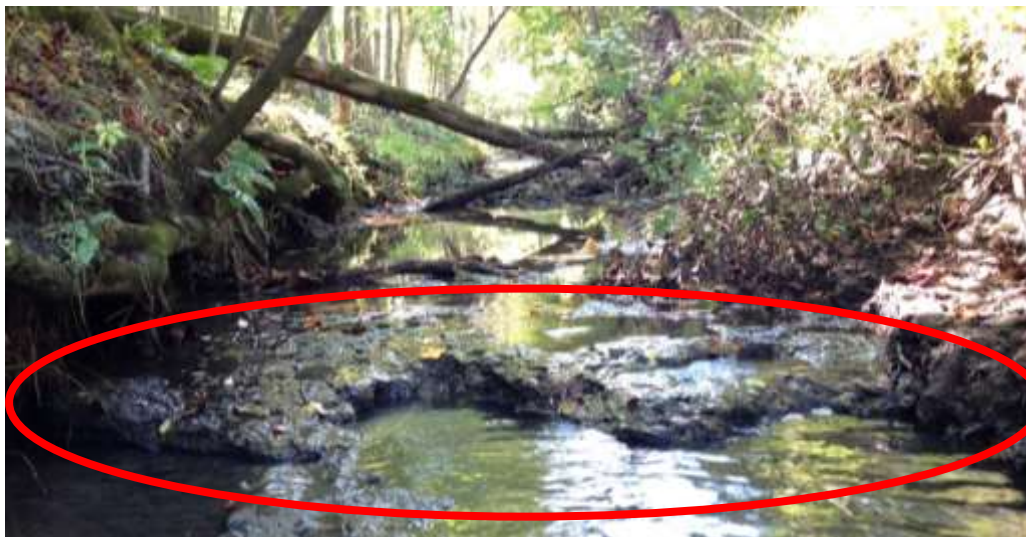
Figure 5-1. Example of stream head cut.

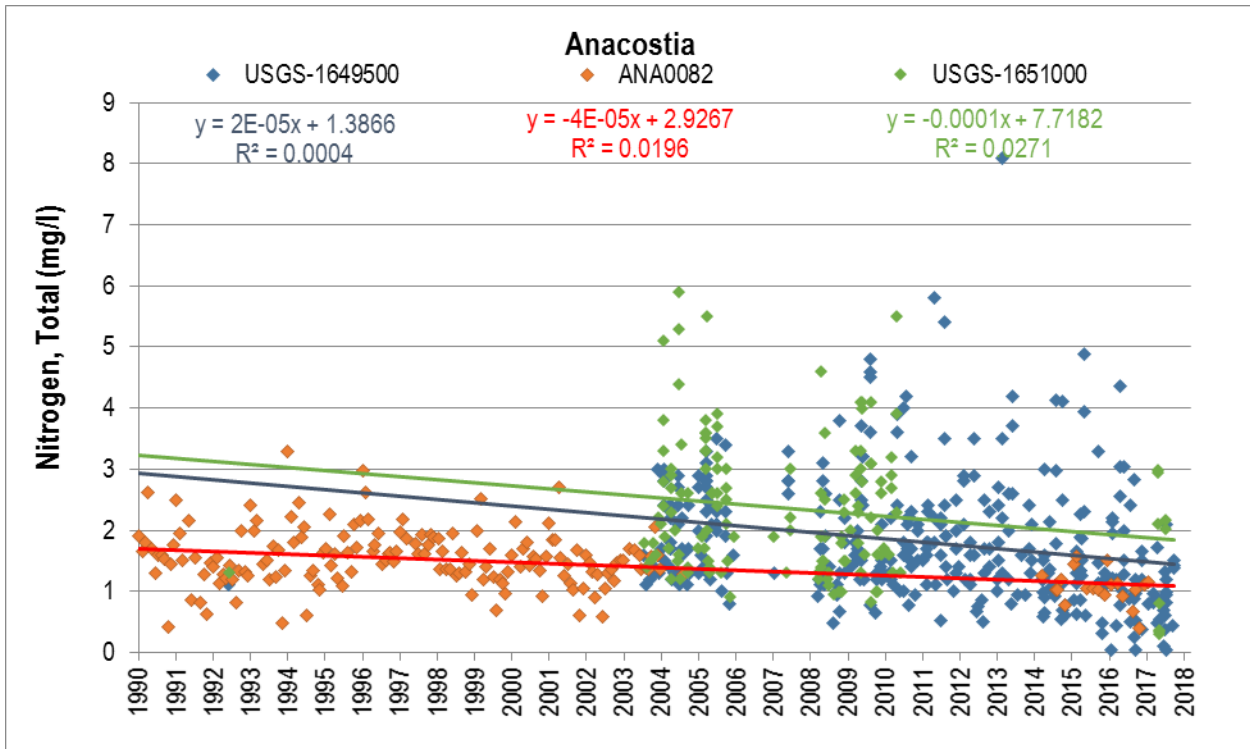
Figure B-3. Plot of TN over time in the Anacostia River watershed.

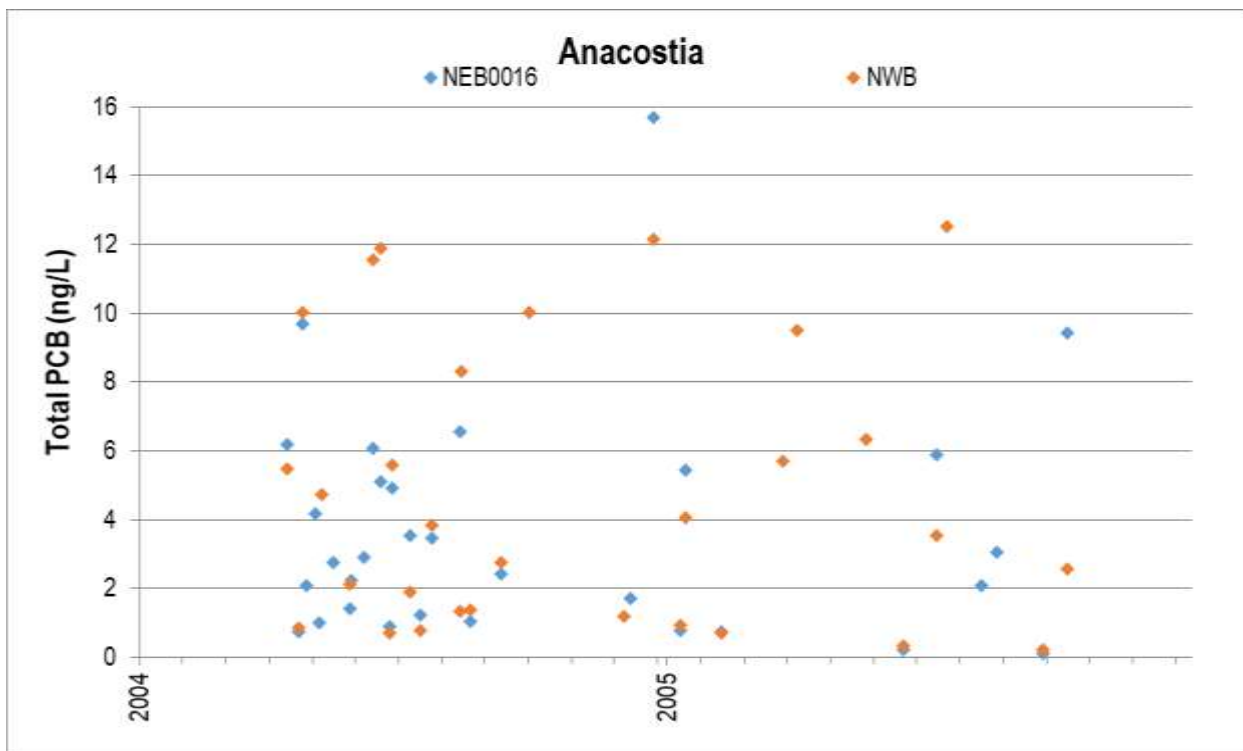
Figure B-39. Total PCBs over time in the Anacostia River watershed.
