# Restoration Plan for the Western Branch Watershed in Prince George's County

Prepared for:  
Prince George's County, MD  
Department of the Environment  
Stormwater Management Division  
1801 McCormick Drive, Suite 500  
Largo, MD 20772

Prepared by:  
Tetra Tech, Inc.  
10306 Eaton Place, Suite 340  
Fairfax, VA 22030

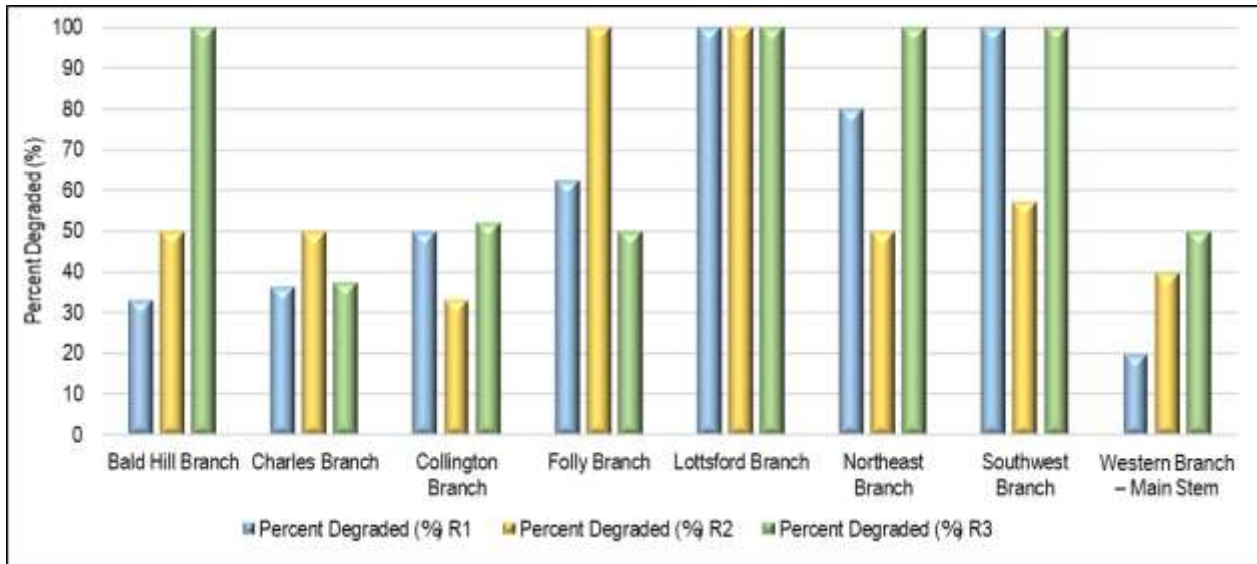
Figure 3-12. Western Branch subwatershed percent degraded.

The biological data reveal that the Western Branch watershed consistently had high levels of degradation through the three assessment rounds. Figure 3-12 summarizes the monitoring results by subwatershed. Figure 3-13 presents the biological assessment narrative ratings by monitoring location for rounds 1 through 3. A significant number of sites were rated as Fair and a few as Good, but many more were rated as degraded (Poor and Very Poor), which in many cases could reflect the high percentage of impervious surfaces in the watershed. The level of degradation for the Western Branch ranged from 49.1 percent (R2) to 62.8 percent (R1).

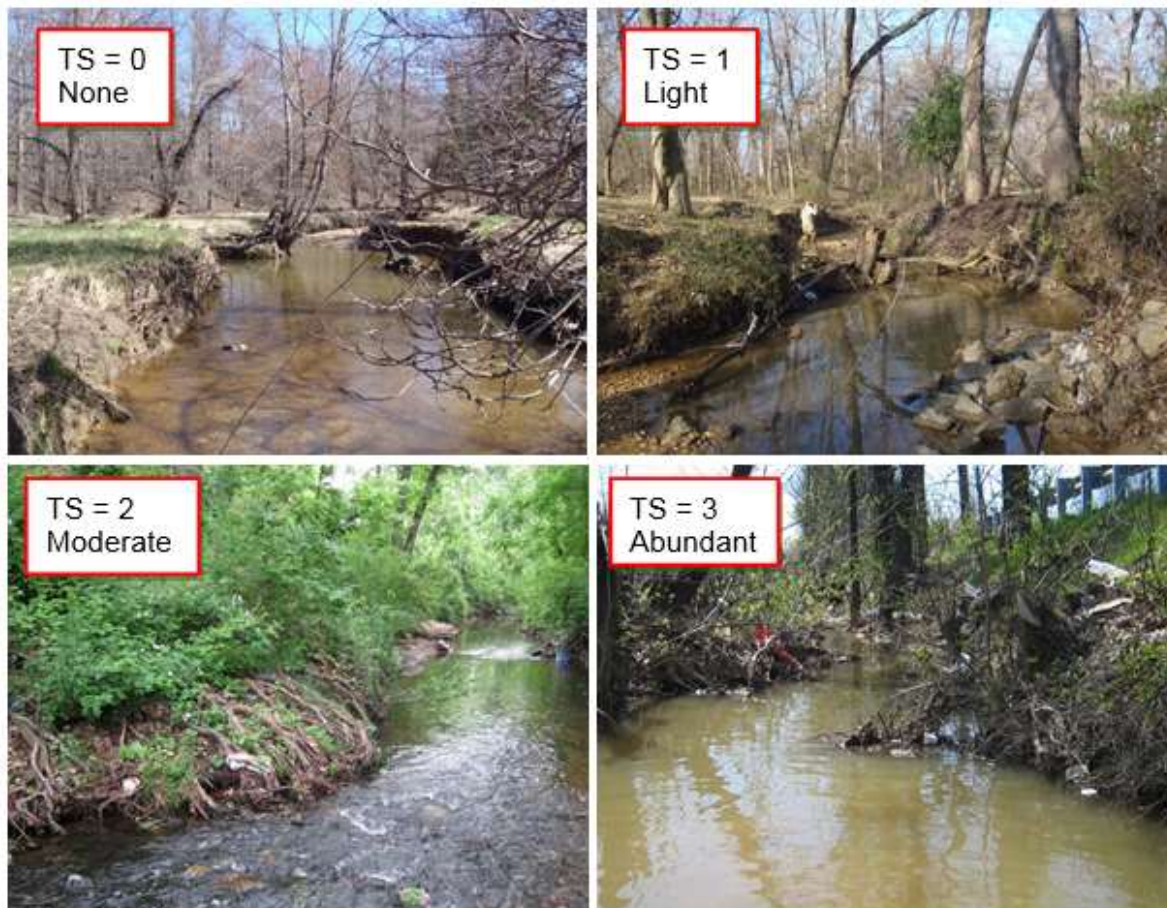
Figure 3-14. Photographs illustrating different amounts of trash and corresponding trash score.

Figure 3-14 shows four photographs that demonstrate what each major level in the rating scale represents. After each photo from a site was rated, an aggregate score for all the photos taken at the site was calculated. If there were four photos, the scores were simply totaled. If more than four photos had been taken, the scores were averaged and multiplied by four. Consequently, the trash score for a single site could range from 0 (no trash) to 12 (heavy trash).

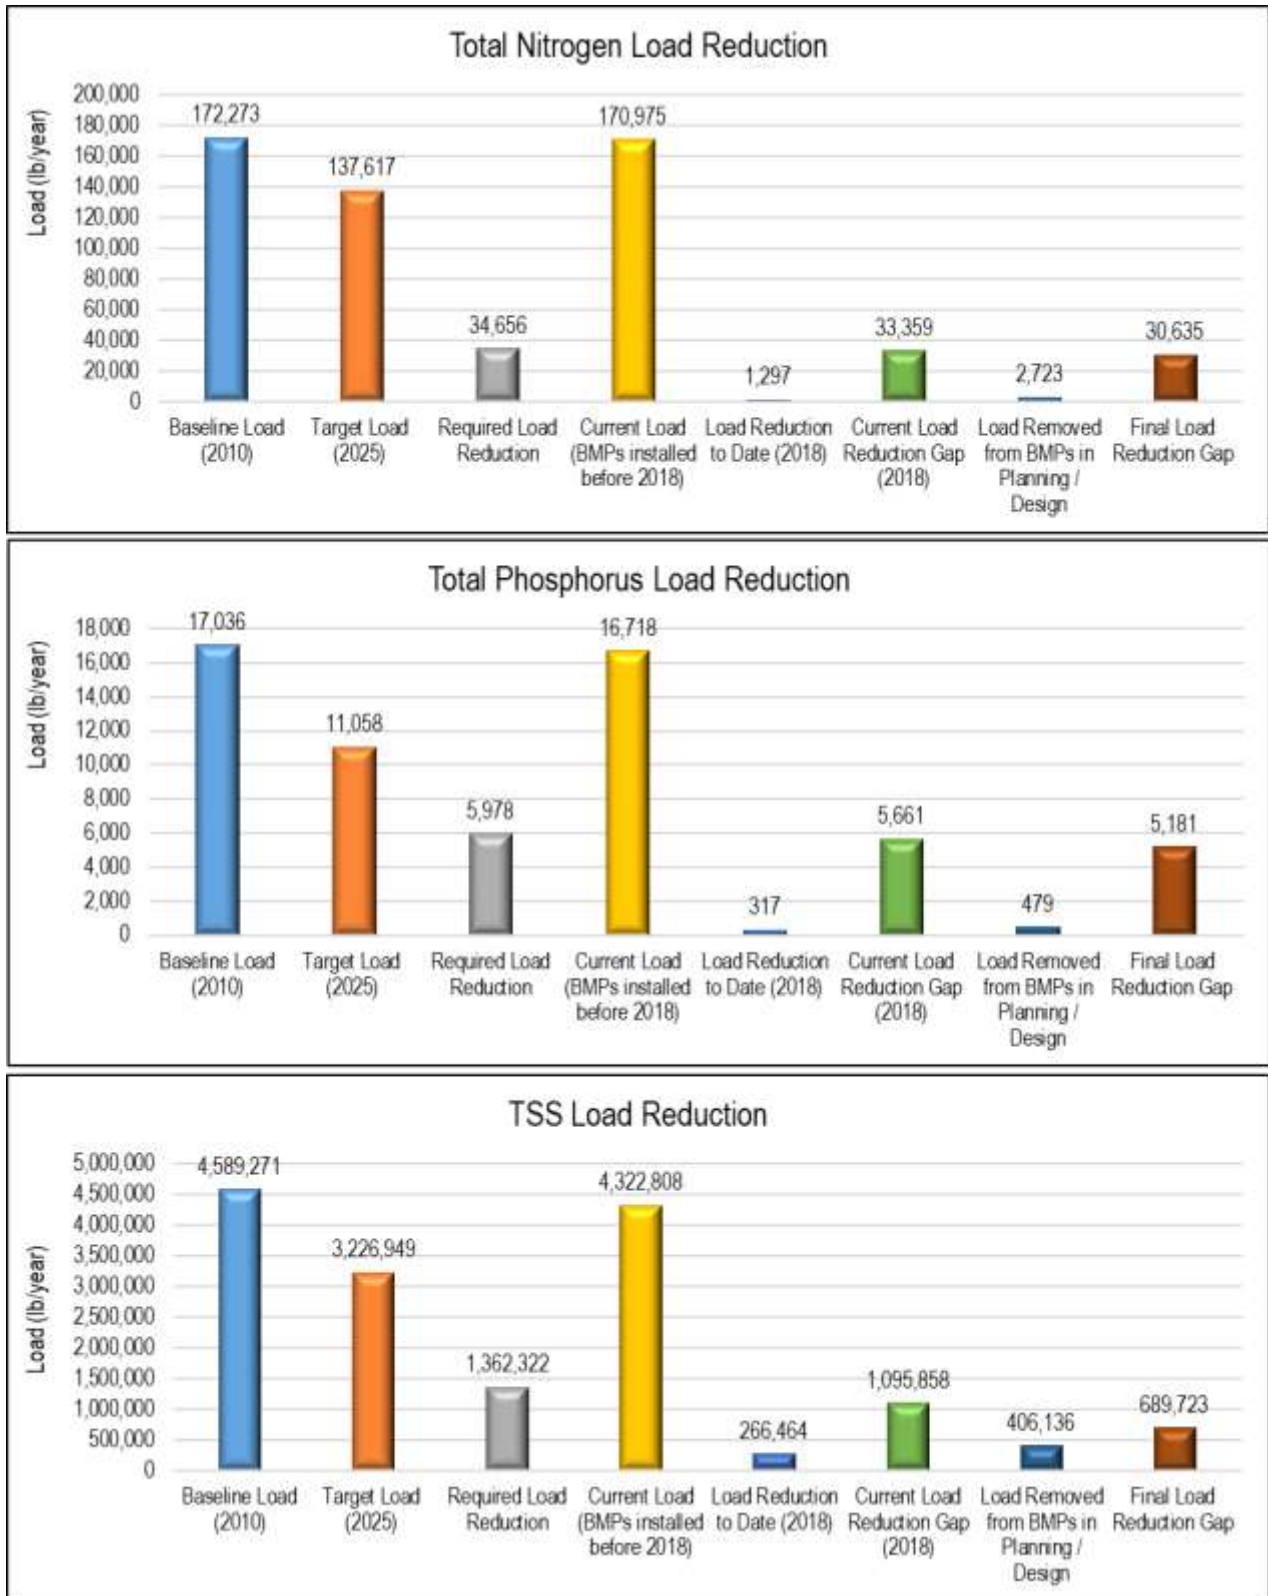
Figure 5-2. Pollutant load reduction targets and gaps for the Western Branch watershed.

As shown in Table 5-1, the load reductions from existing restoration activities are not sufficient to meet the targeted reductions. Even with the BMPs that the County is already planning or designing, the load reduction targets will not be met, so additional practices need to be planned.

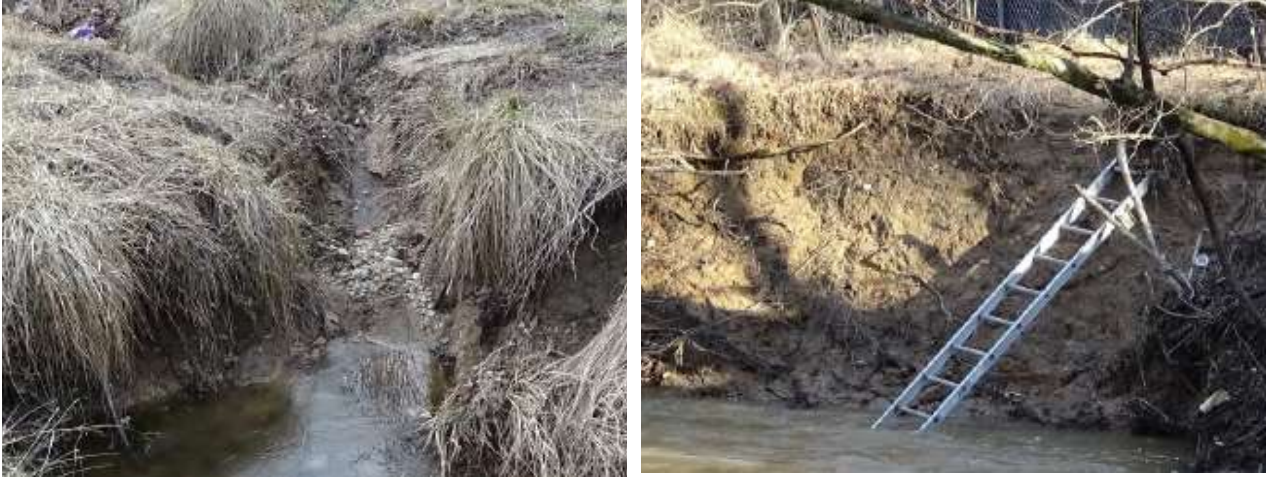
Figure 5-4. Examples of stream erosion.

The Western Branch watershed contains a dense network of streams that are extensively degraded (Figure 5-4). Stream flow is primarily nontidal, with the lower 5 mi—below the State Route 4 bridge—influenced by tides on the Patuxent River. The MBSS for 1997–1999 indicates that 42 percent of streams in the County are degraded or severely degraded, while 36 percent are partially degraded. Urban stream restoration might be a highly desirable BMP option. The County’s extensive biological monitoring database will be used to identify degraded streams and potential restoration opportunities.

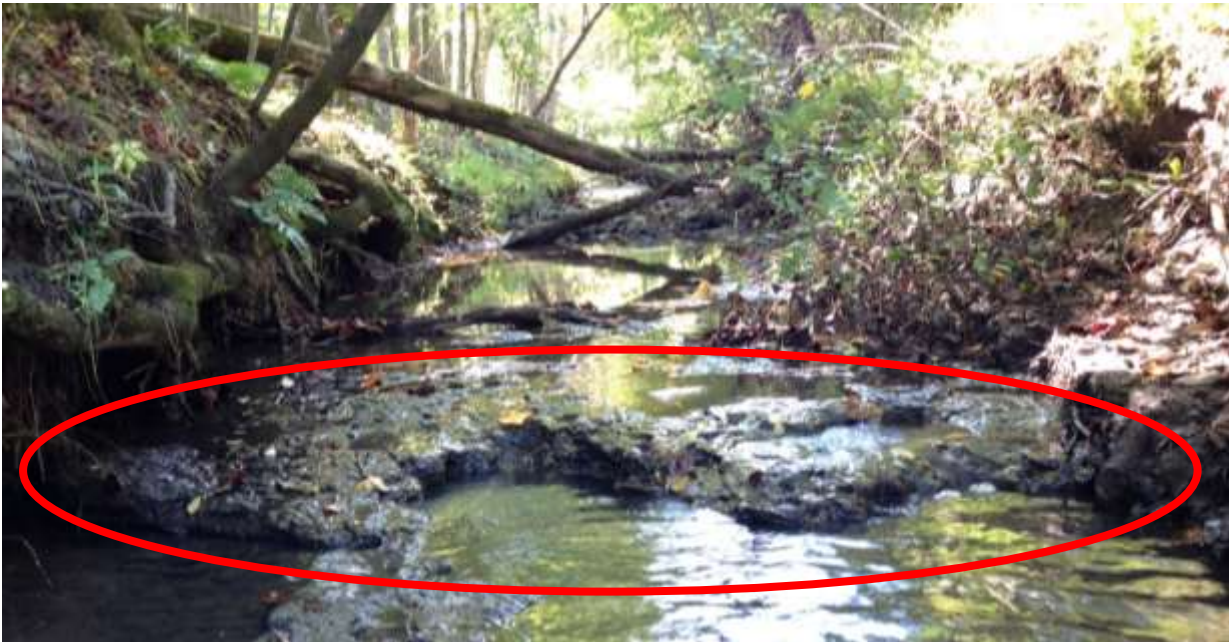
Figure 5-5. Example of a stream head cut.

Severe erosion, or head cuts, have been observed in the Western Branch watershed, which is a strong indication that there are opportunities for stream restoration in the County (Figure 5-5). A head cut is where there is a sharp change in stream bed elevation due to erosion of the stream bed. These areas continue to erode in an upstream direction, releasing sediment that is conveyed downstream.

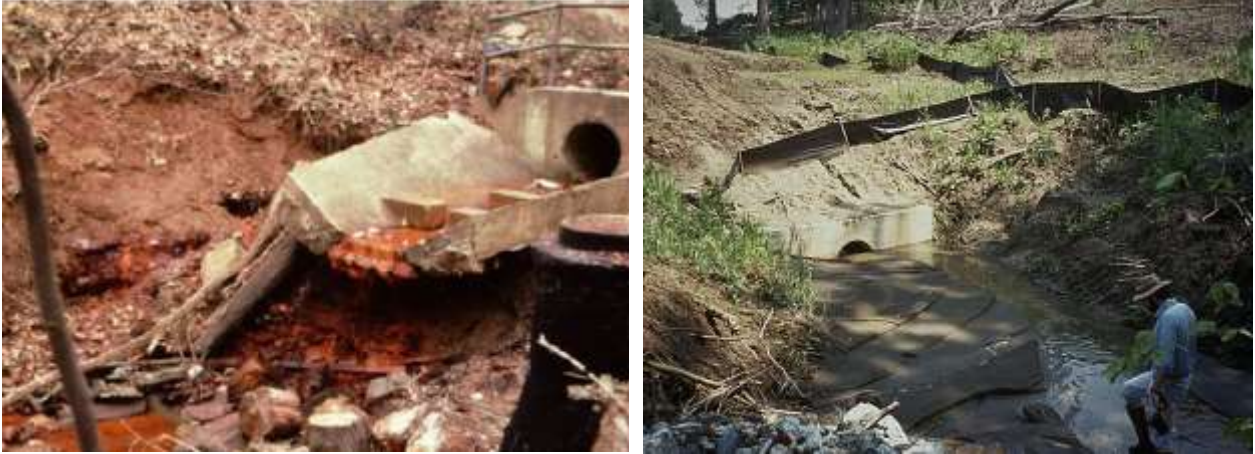
All storm drainage systems in the County terminate at outfall structures that usually discharge to surface drainage features such as channels or streams. The outfall structures are often the initial source for stream erosion and degradation because they are the delivery point for the increased runoff from impervious areas. As the stream channel erodes and down cuts, it often undercuts the outfall structure, resulting in outlet failure (Figure 5-6).

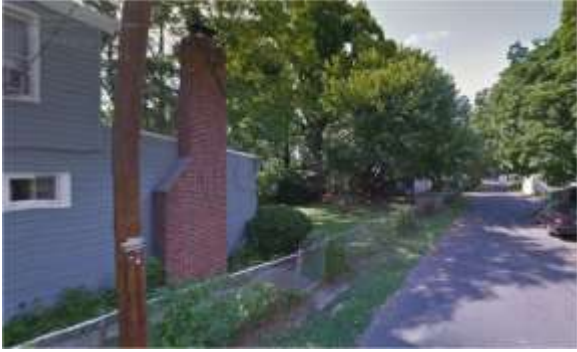
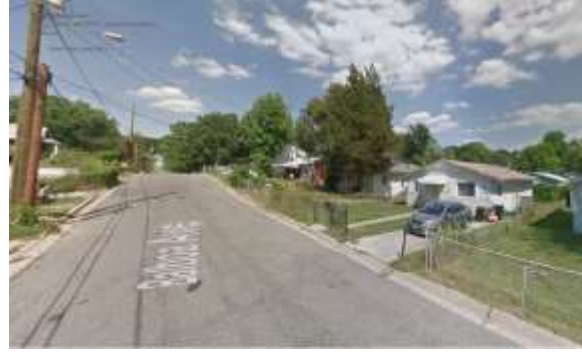
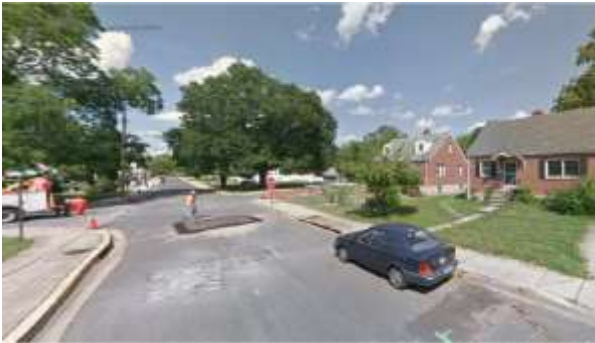
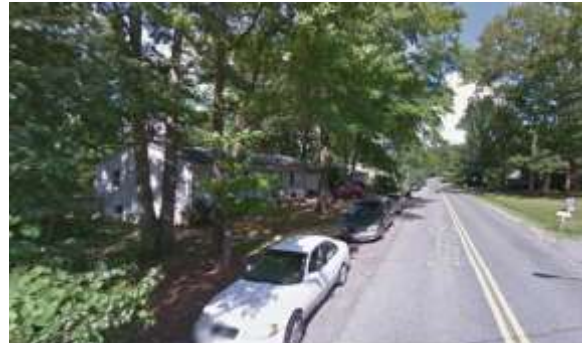
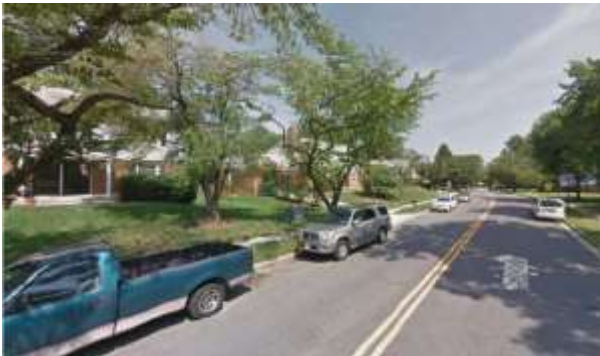
Figure 5-7 provides examples of the different groupings. County ROWs can be present along a road in any of these groupings. Each grouping has its own set of potential BMPs. Table 5-2 is a matrix of road groupings and potential BMPs for ROWs along each type of road. Before BMPs are planned for ROWs on open suburban roadways, MDE's requirements for nonrooftop impervious area disconnection should be evaluated to determine if the road can be considered disconnected.

Urban open section with no sidewalk: Mt. Rainier–Varnum Street.

Urban closed section with curb and gutter but no sidewalk: Capitol Heights–Balboa Avenue.

Urban closed section with curb, gutter, and sidewalk: Mt. Rainier–39th Place.

Suburban open section with no curb, gutter, or sidewalk: Glendale–Dubarry Street.

Suburban closed section with curb, gutter, and sidewalk: Kettering–Herrington Drive.

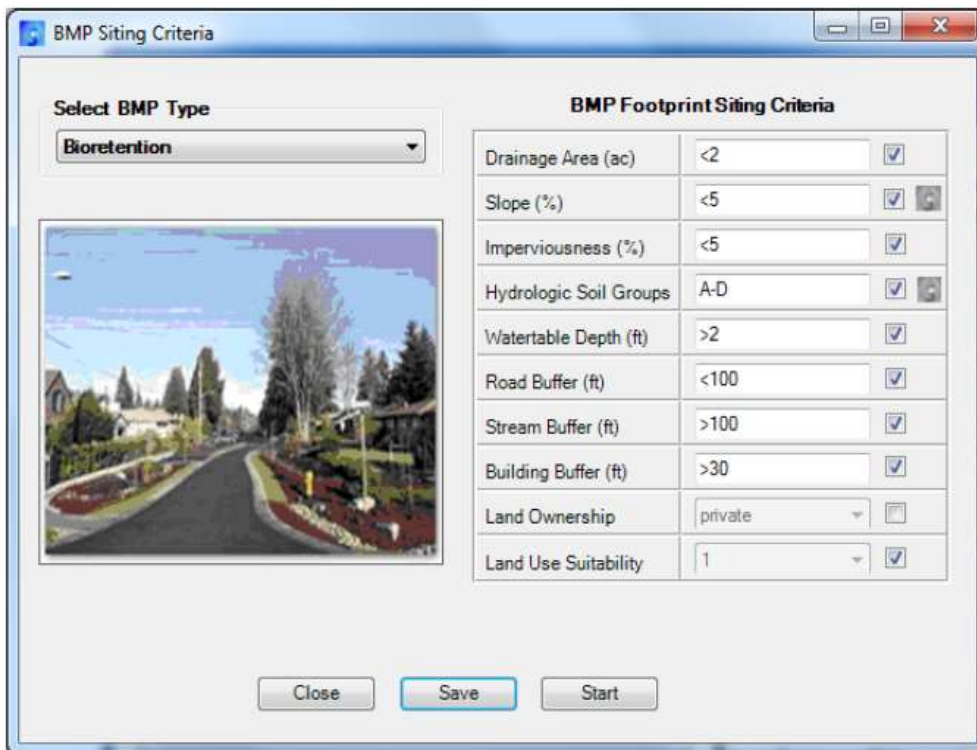
Figure 5-8. Examples of urban road BMP Siting Tool criteria input screen.

BMP Type	Drainage Area (acre)	Drainage Slope (%)	Impervious Area (%)	Hydrologic Soil Group	Water Table Depth (ft)	Road Buffer (ft)	Stream Buffer (ft)	Building Buffer (ft)
Bioretention	< 2	< 5%	> 0%	A-D	> 2	< 100	> 100	--
Cistern	--	--	--	--	--	--	--	< 30
Grassed swale	< 5	< 4%	> 0%	A-D	> 2	< 100	--	--
Green roof	--	--	--	--	--	--	--	--
Infiltration basin	< 10	< 15%	> 0%	A-B	> 4	--	> 100	--
Infiltration trench	< 5	< 15%	> 0%	A-B	> 4	--	> 100	--
Porous pavement	< 3	< 1%	> 0%	A-B	> 2	--	--	--
Sand filter	< 10	< 10%	> 0%	A-D	> 2	--	> 100	--
Vegetated filterstrip	--	< 10%	> 0%	A-D	> 2	< 100	-	--

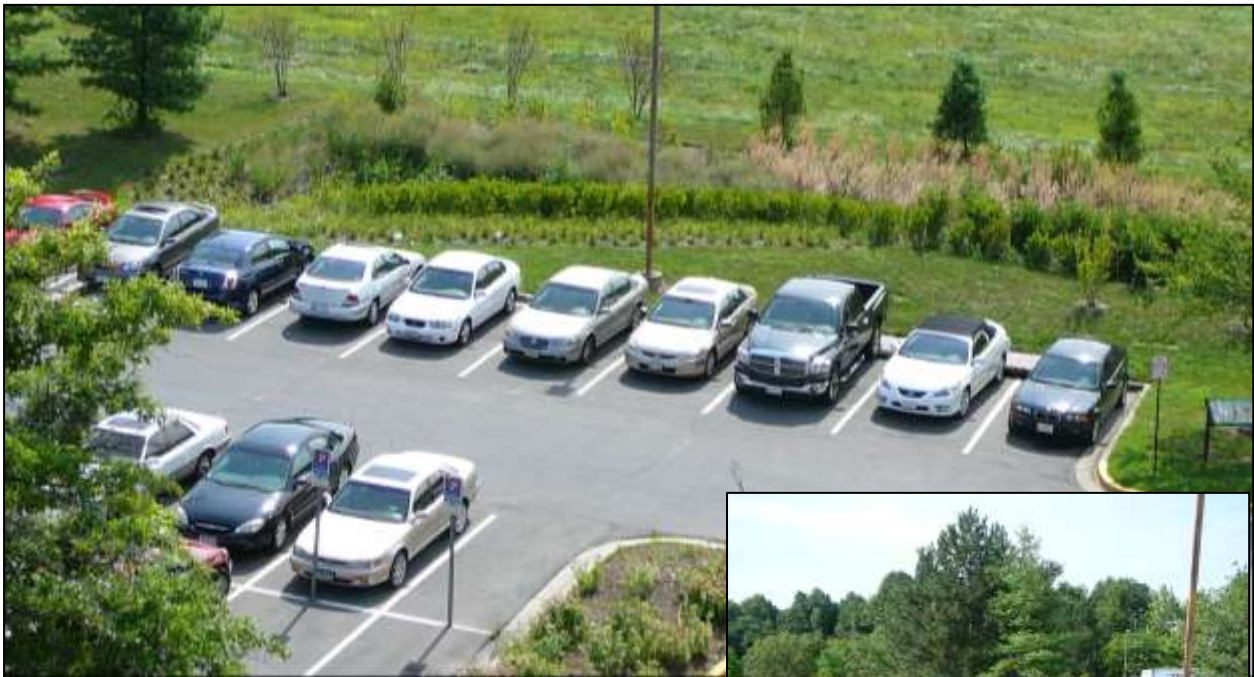
*Aerial and ground level view of bioretention facility collecting runoff from parking lot at County office building in Largo.*

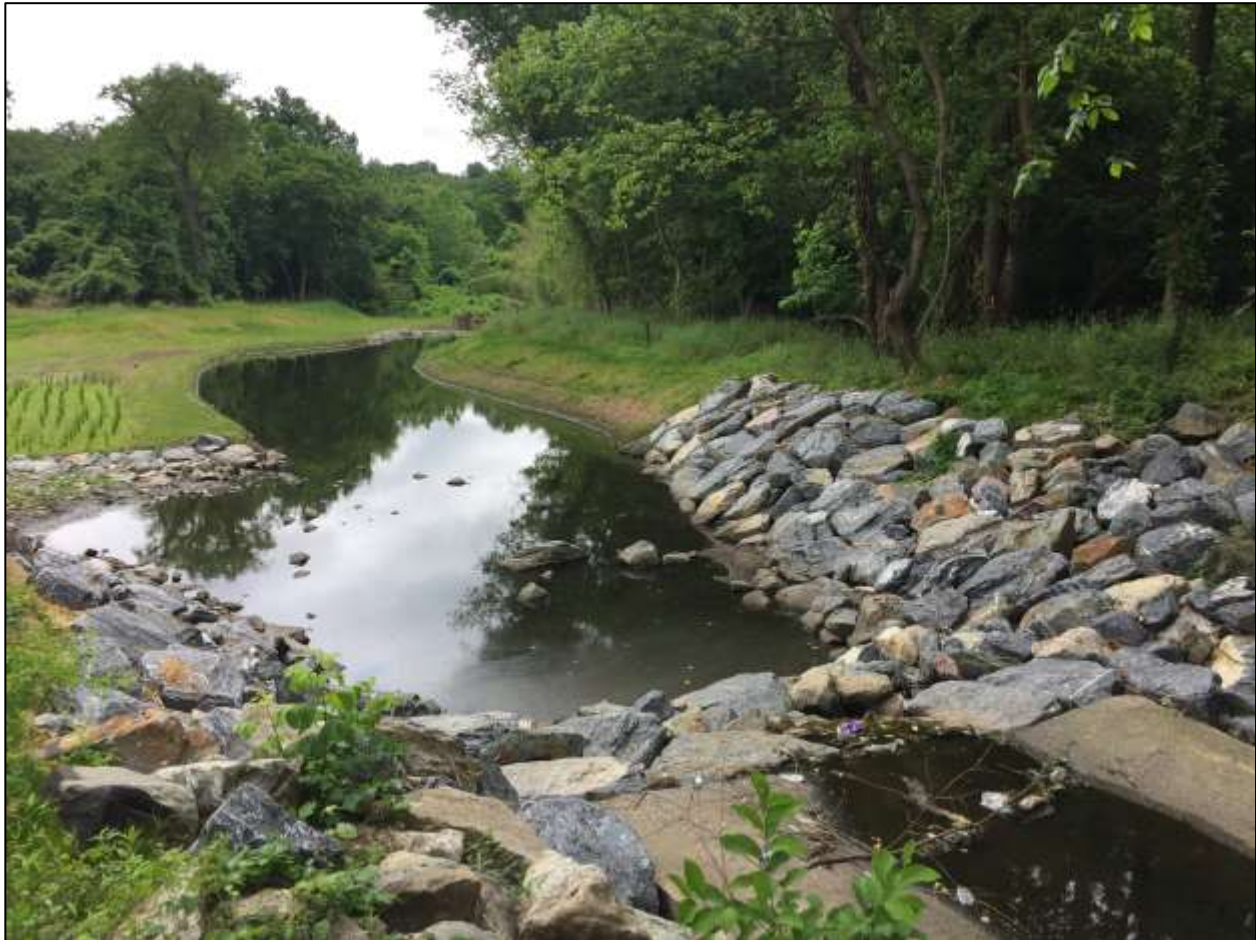
*Recently completed stream restoration project. Rocks were used to stabilize the banks and fresh vegetation was planted along the left and right banks.*

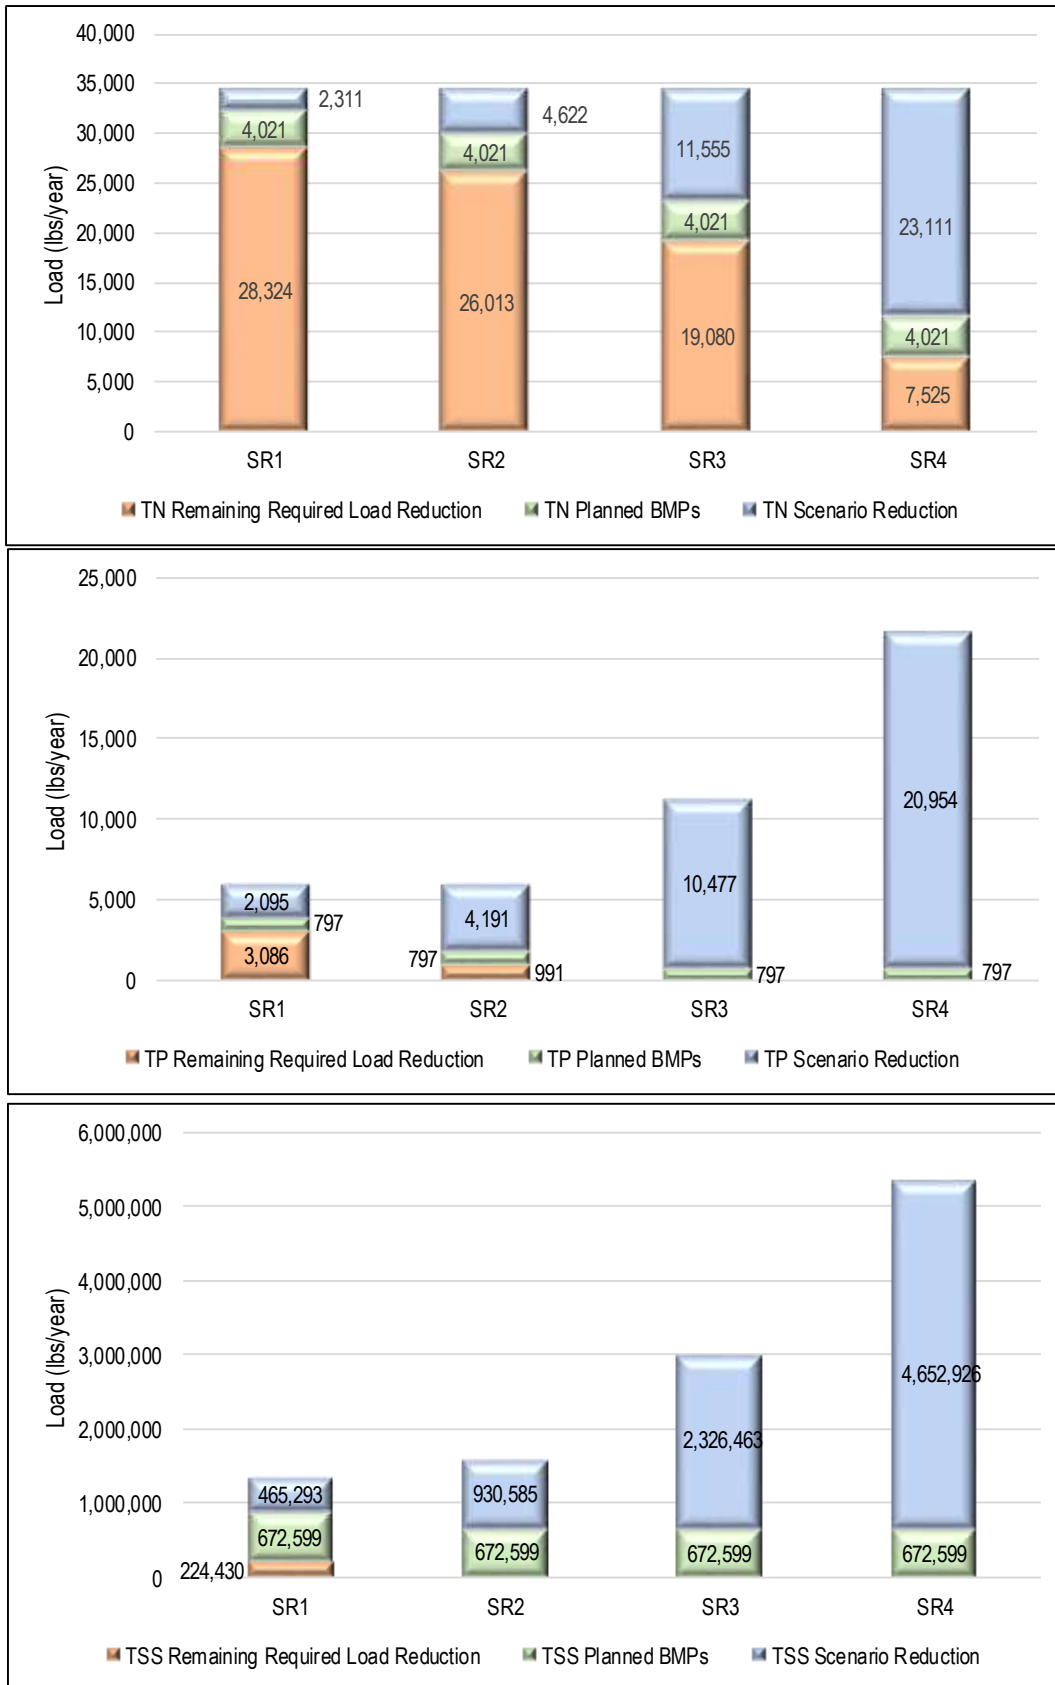
Figure 6-1. Summary of urban SR scenarios (Table 6-2).

The outcomes of each scenario were quantified in terms of both pollutant load reductions and impervious area credited (Table 6-2). The load reductions were calculated using MDE guidance (MDE 2014). Figure 6-1 illustrates how SR3 and SR4 will meet load reductions for phosphorus and TSS, while SR2 will also meet reductions for TSS.

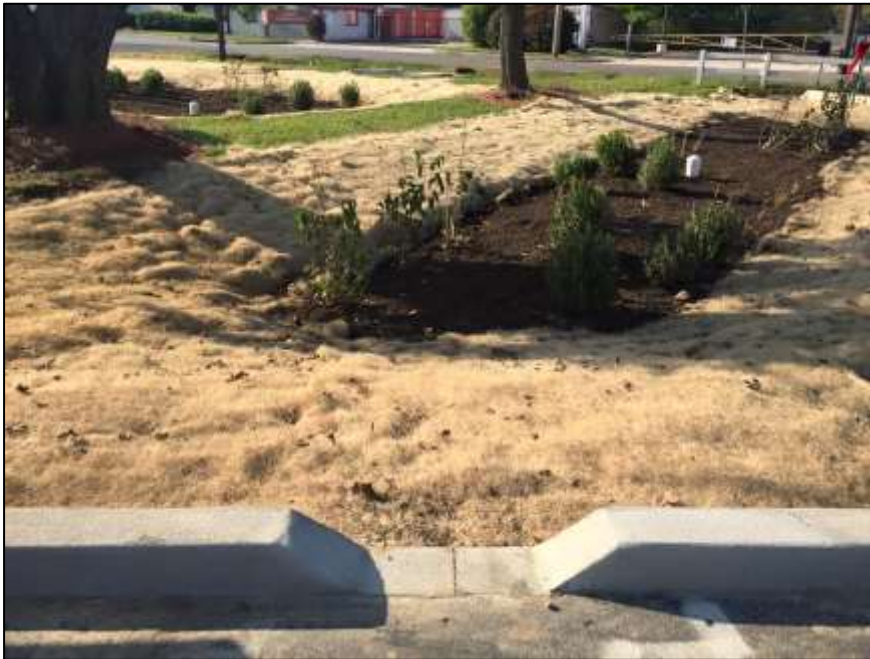
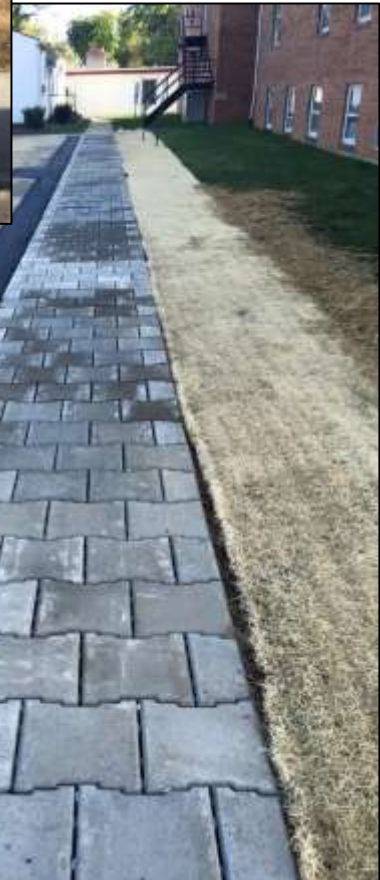
*Bioretention facilities (above) and permeable pavement (right) installed by the Clean Water Partnership as part of the Alternative Compliance Program.*
